# DEGRADATION OF CZECHOSLOVAK CREEP RESISTANT STEELS AFTER 50 YEARS OF SERVICE

The aim of this article is at bases information obtained from fifty years of degraded materials to obtain information for more accurate reference catalogue. This catalogue can on bases information obtained from the microstructure and hardness estimate the state of degradation or possible time to rupture for the material.

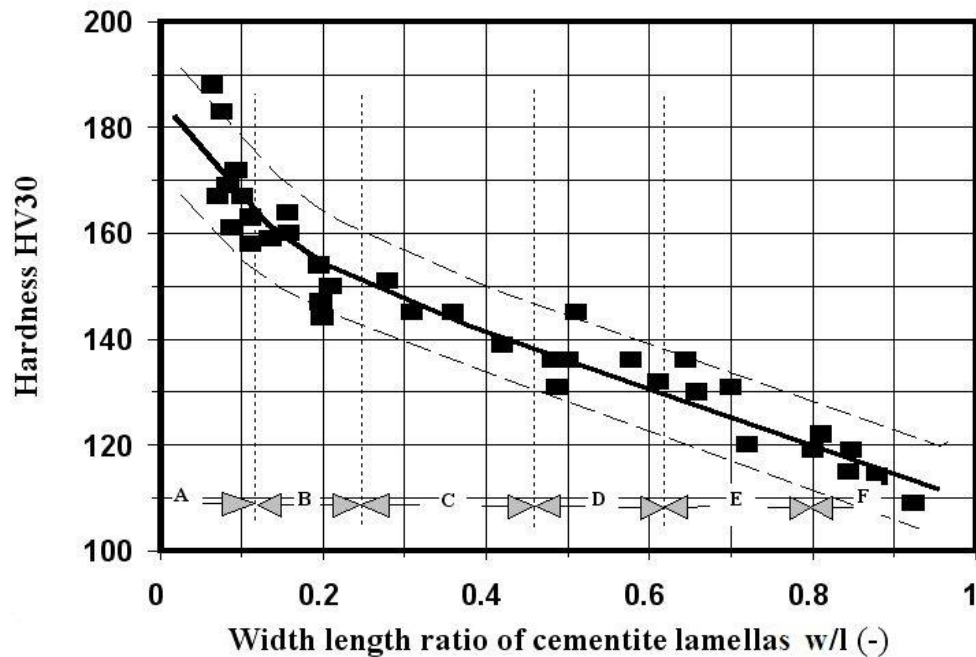
Fig. 1. The dependence of hardness on globularisation of cementite for ČSN steel 12 022.

Fig. 1 shows an experimentally determined dependence of hardness HV on the ratio  $w/l$ . The graph in Fig. 1 includes the limits of tolerance hardness values for probability  $p = 0.95$ .

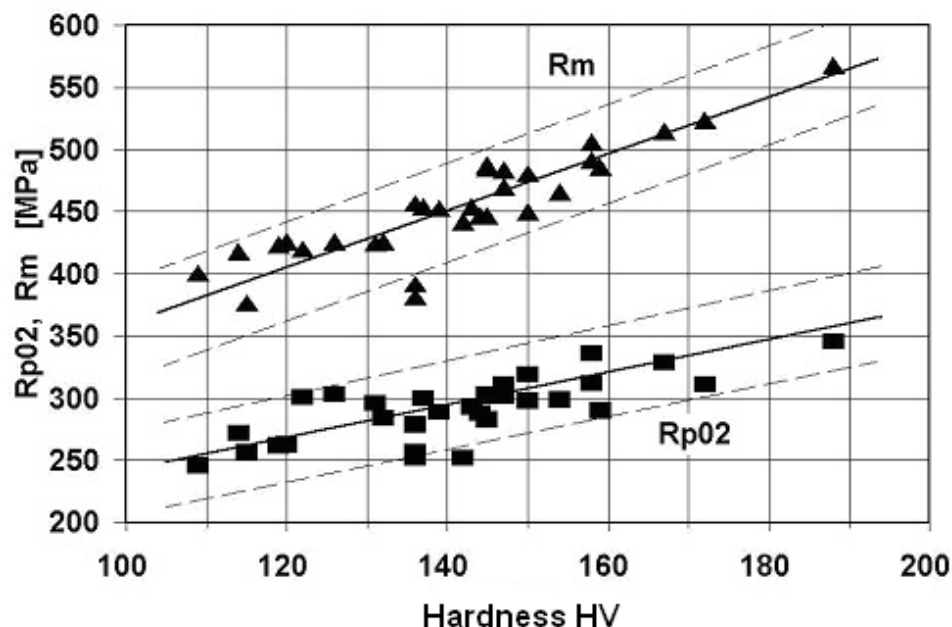
Fig. 2. The dependence of strength on hardness of ČSN steel 12 022.

Next, results of mechanical properties obtained from tensile strength tests allowed creating a relationship between hardness, yield strength, and tensile strength (see Fig. 2). The graph in Fig. 2 includes the limits for  $p = 0.95$  again. At the same time, values and relative proportions of strength properties and hardness were observed. It was found that it is not constant, but the value  $R_{p02}/HV$  and  $R_m/HV$  depends on the degree of degradation of the structure.

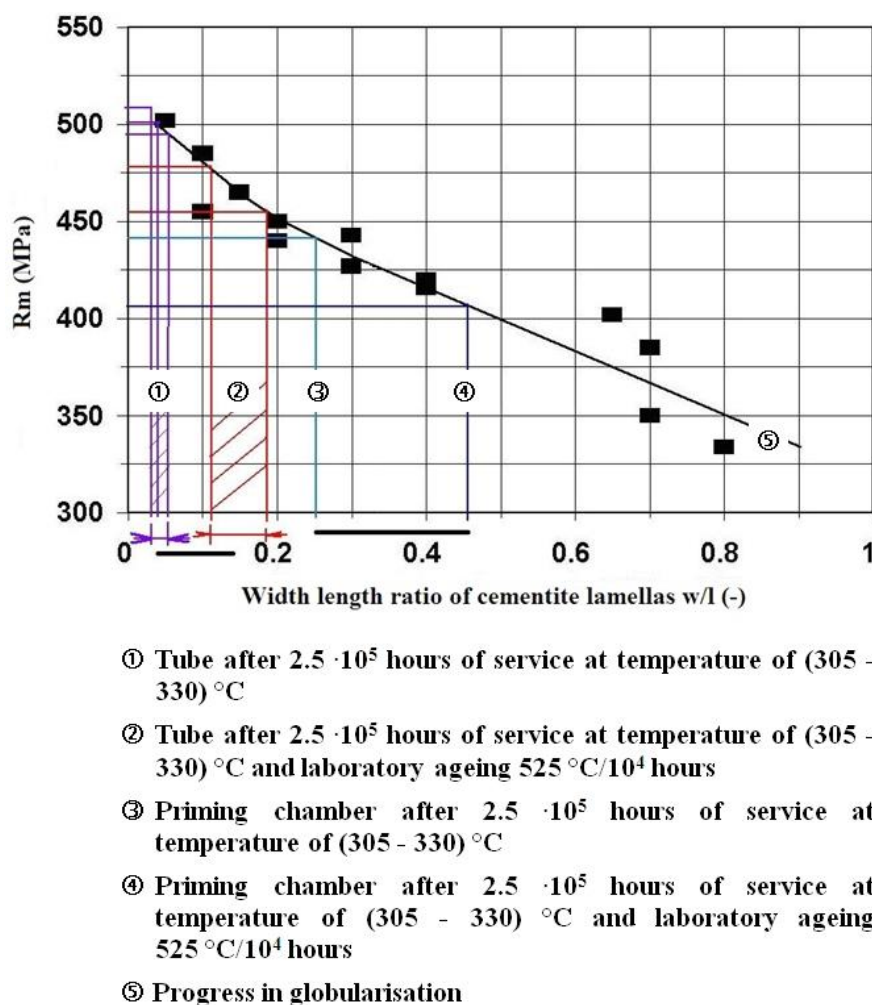
Fig. 3. The dependence of tensile strength on structural parameters.  
(full colour version available online)

By plotting of dependence of hardness on globularisation of cementite in pearlite grain (ČSN steel 12 022) obtained after fifty years of operation and subsequent laboratory exposure we get the graph in Fig. 3. The experiment confirmed the expectation that the pressure system operating at low temperatures does not face significant structural changes even after more than fifty years of operation. The experiment is in accordance with the generalised dependence of strength on the structural parameters (see Fig. 3). According to the values measured on the parts of one of the closed pressure system it appears that the resistance of the structure against the structural changes (specifically globularisation of pearlite in ČSN steel 12 022) is not linear and decreases with increasing content of globularised pearlite. This is shown by a change of generalised dependence in Fig. 3.
